MARYLAND HISTORICAL TRUST  
DETERMINATION OF ELIGIBILITY FORM

Property Name: Wilcom Farmstead Inventory Number: F-7-142  
Address: East side of Big Woods Road Historic district: ☐ yes ☒ no  
City: Ijamsville Zip Code: 21754 County: Frederick  
USGS Quadrangle(s): Urbana  
Property Owner: John Wilcom, Jr. et al and Mary Jane Dudderar Tax Account ID Number: 210647  
Tax Map Parcel Number(s): 25 Tax Map Number: 97  
Project: Maryland 80 at Ijamsville Road Agency: Maryland State Highway Administration  
Agency Prepared By: Maryland State Highway Administration  
Preparer's Name: Stephanie Foell Date Prepared: 12/29/2005

## Wilcom Farmstead (F-7-142)

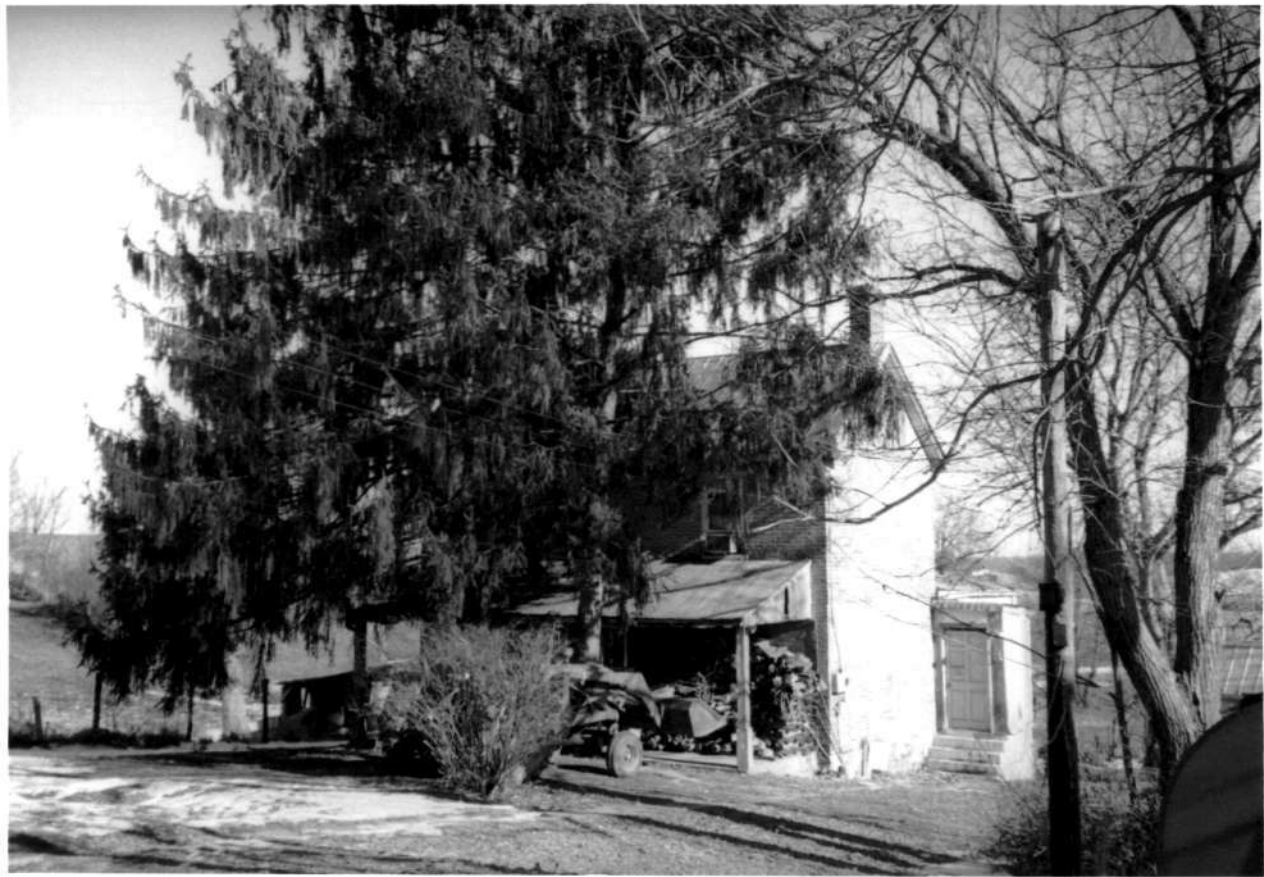
1/5

View of residence; view to the northeast

The residence is a modest two-story brick house that is devoid of architectural ornamentation. It has a rectangular footprint and a side-gable roof that is covered in standing-seam metal. A single-story, full-width, shed-roof porch covers part of the façade and appears to have been added after the original construction. Original windows have been obscured with the installation of air-conditioning units and also by an immense stack of firewood on the porch, but appear to have been four-over-four, double-hung sash configurations. A brick chimney extends from the ridge line. A covered entrance extension extends from the side of the house. The house is in poor condition.

While the house dates to 1800, it has been altered by the addition of the full-width porch that now dominates the façade. Insensitive alterations and maintenance has compromised the historic character of the building. Because the house and agricultural buildings are from different eras, the site lacks a cohesive appearance and period of significance. Within Frederick County and other western Maryland counties, there are numerous other agricultural properties that present a more unified historic appearance and that have higher levels of integrity. Most notably, the Singleton Burgee House (F-7-6), located less than one mile to the east, contains a better preserved circa 1800 house and associated agricultural buildings.

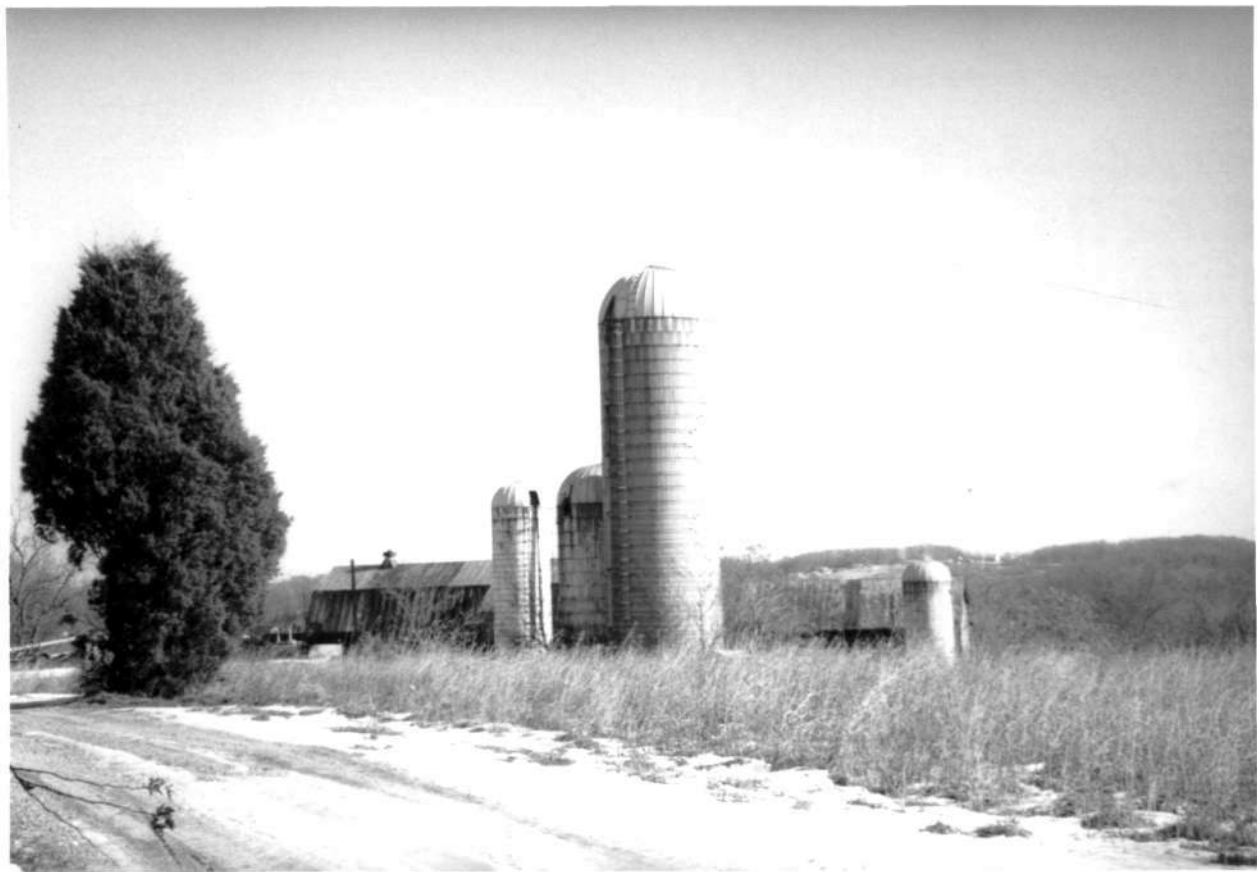
2/5

View of agricultural buildings; view to the  
southeast

Agricultural buildings dominate the site. Silos of varying heights from different eras are present. They are concrete construction with hemispherical domes and likely date to the first half of the twentieth century. A deteriorated gambrel roof barn constructed of wood and concrete blocks has a metal roof with ridgeline ventilators. Double sliding doors allow access to the barn, and a series of small windows provide light and ventilation. Doors to the hay loft are present on the roof and in the gambrel area. An attached gable-roof milking parlor is present. These buildings all relate to dairy farming and are clustered together. A slight distance away, a gable-roof barn is present. It is clad in vertical wood boards that are substantially deteriorated and the roof is covered with corrugated metal panels. A dilapidated frame shed is located nearby.

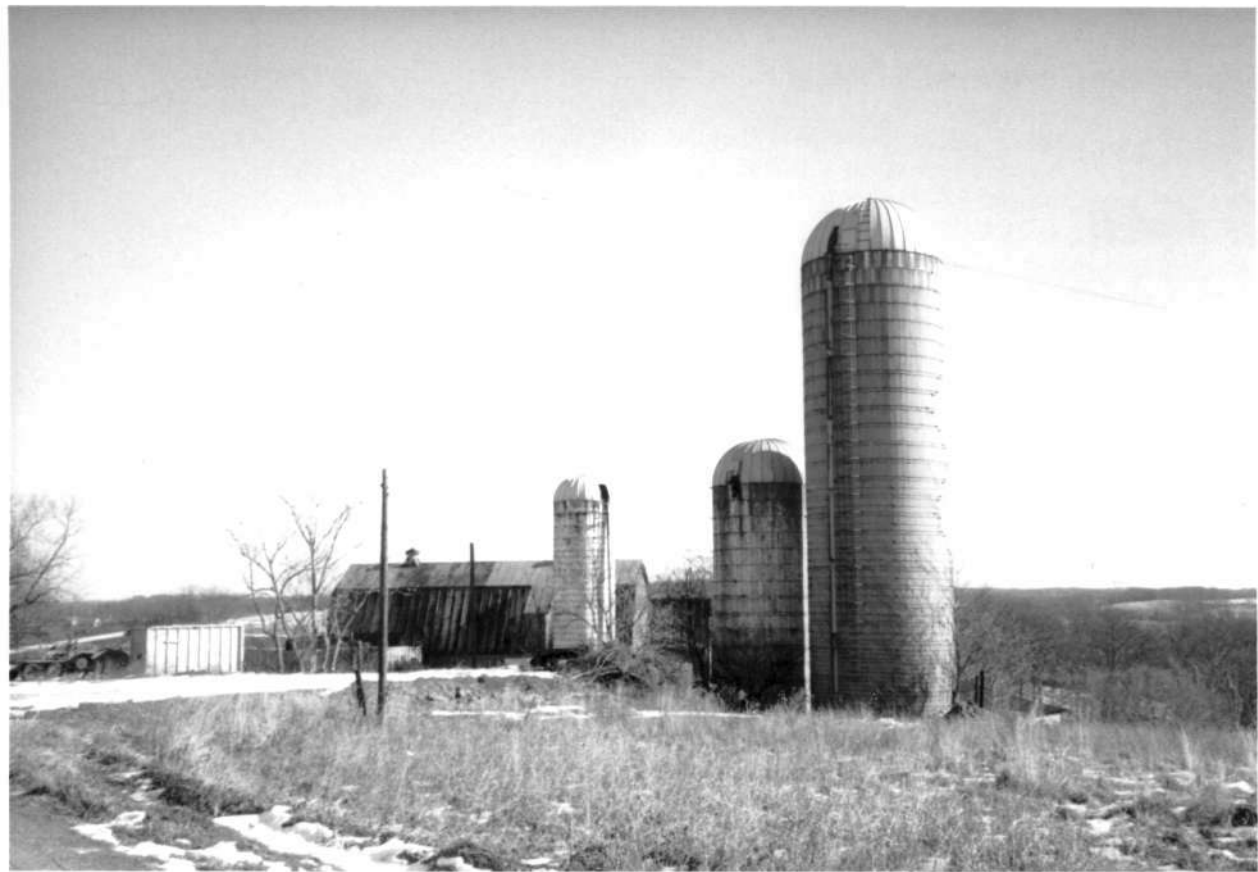
3/5

View of agricultural buildings, view to the  
southeast

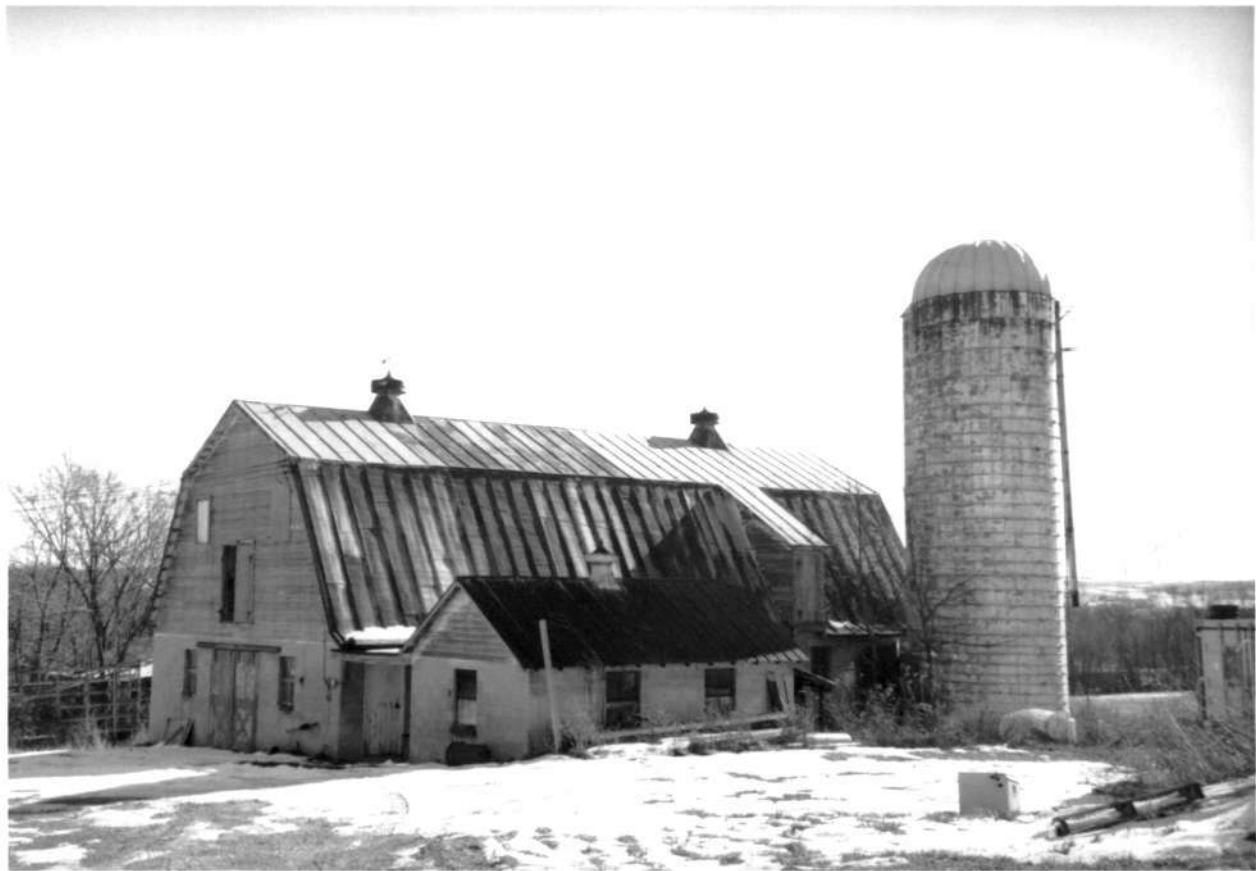
4/5

View of dairy barn and silo; view to the  
southeast.

The larger gambrel-roof barn is consistent with the general form of the Wisconsin dairy barn prototype, which was promulgated in agricultural journals in the late nineteenth and early twentieth centuries. Designed by the agricultural engineers at the University of Wisconsin, the barn displayed a logical floorplan that allowed cattle to circulate freely for milking and other routine movement. Wisconsin dairy barn designs included a large number of windows, which were not commonly found on barn design. This allowed light and air circulation into the space, which was thought to promote superior cattle health and increase resistance to common cattle diseases, such as brucellosis. Because the plans were heavily promoted in journals and also by local extension agents, Wisconsin dairy barns became ubiquitous throughout the United States, and numerous examples can still be found in almost any part of the nation that practices dairy farming.

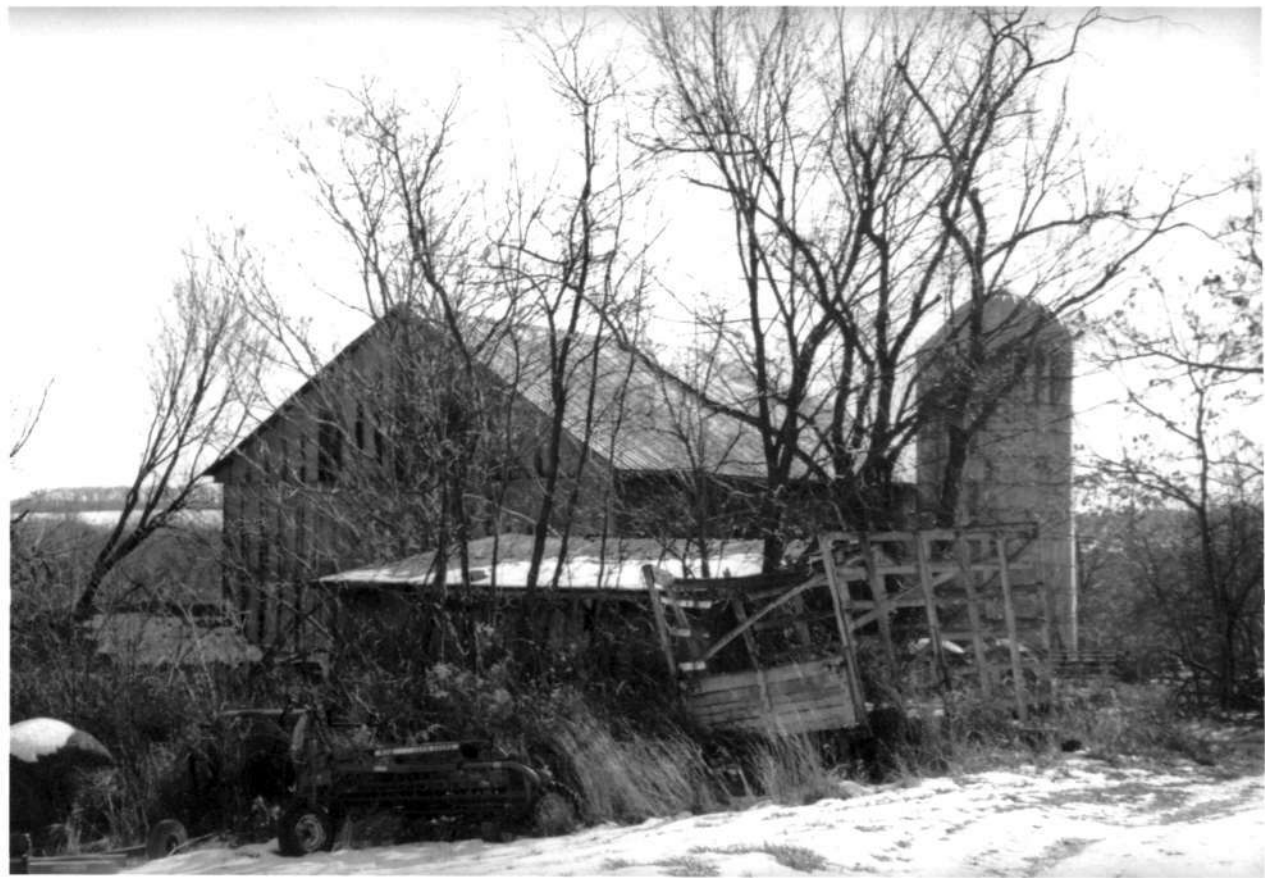
5/5

View of barn and silo; view to the  
southeast
